CITY OF LA VISTA
MAYOR AND CITY COUNCIL REPORT
OCTOBER 6, 2020 AGENDA

Pavement Condition Index Report

Prepared for:
City of La Vista, Nebraska

Project No. 0320015.01
June 2020

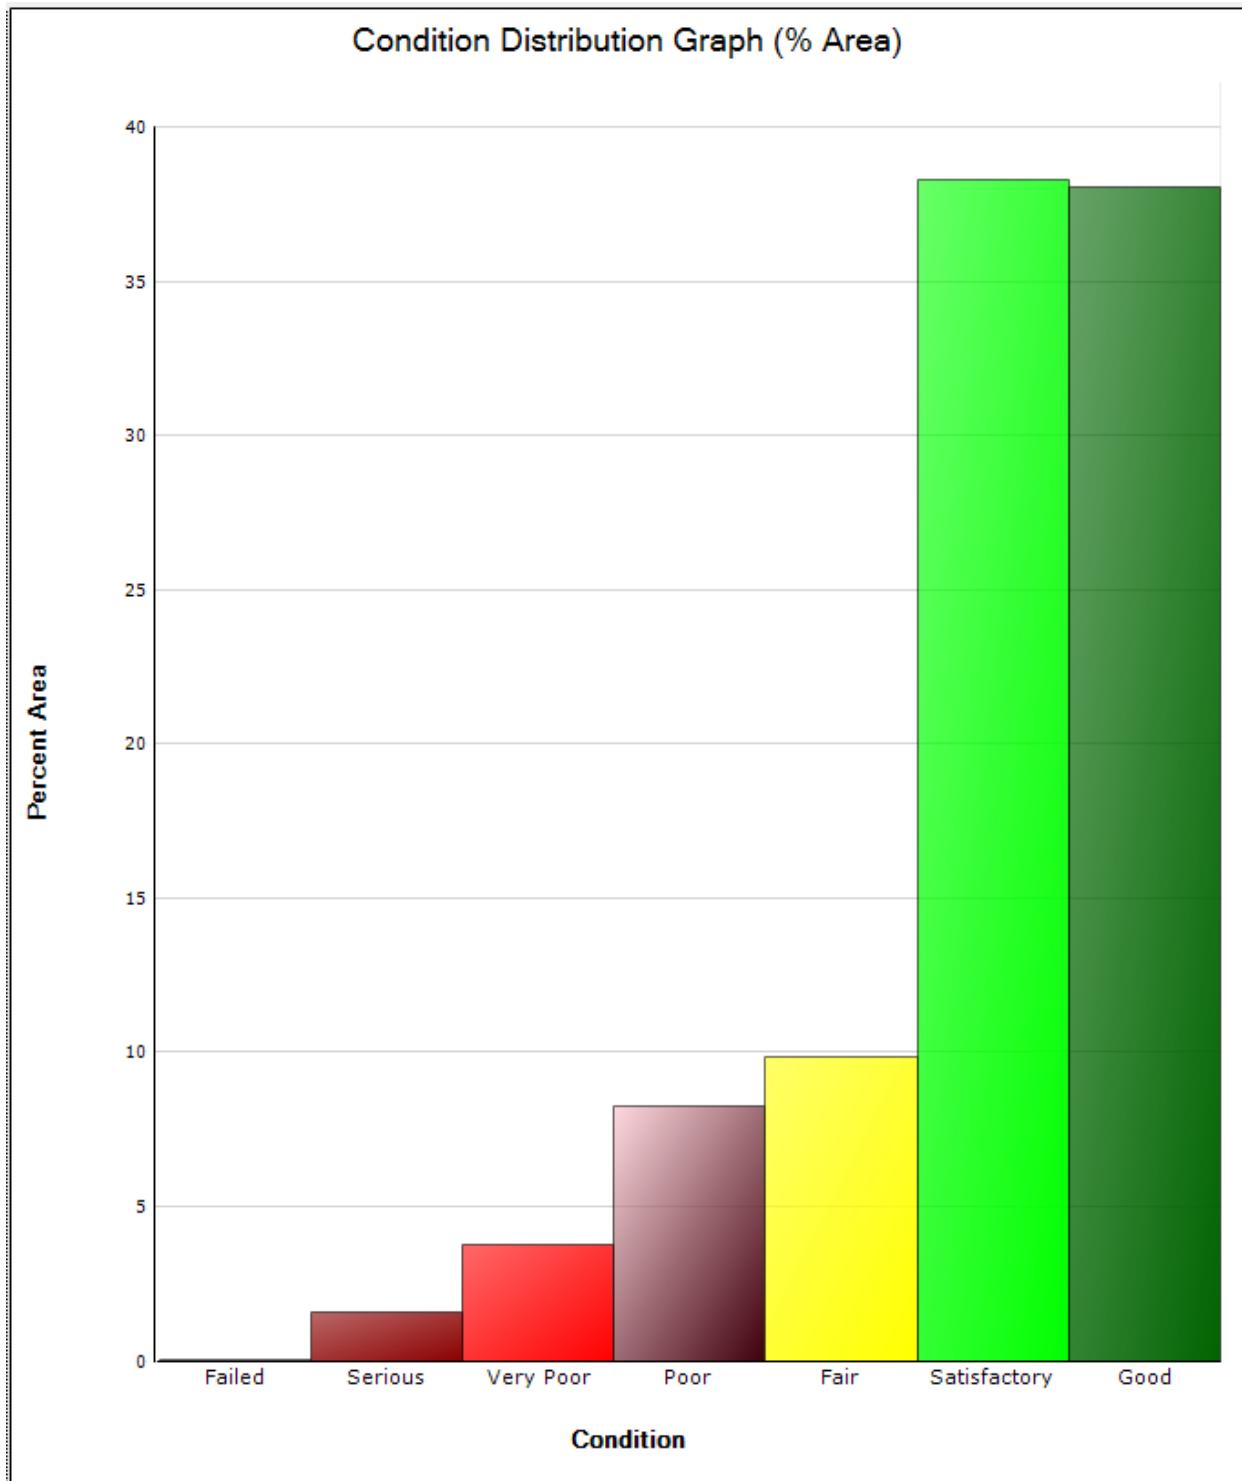
Figure 3: La Vista Street Condition by Area

Table 1 lists La Vista's current street conditions as of April 21, 2020. Its noteworthy that 14% of La Vista's streets are less than fair condition. A street with a PCI less than fair is generally viewed as requiring more than typical street maintenance. Base repairs or full reconstruction may be necessary, with significant additional costs. Typically, a street in a minimum of fair condition can be upheld with routine maintenance.

Figure 3 is a graphical representation for the data in table 1.
