Blight/Substandard Determination Study "84TH Street Redevelopment Area"

La Vista, Nebraska

NOVEMBER 2011

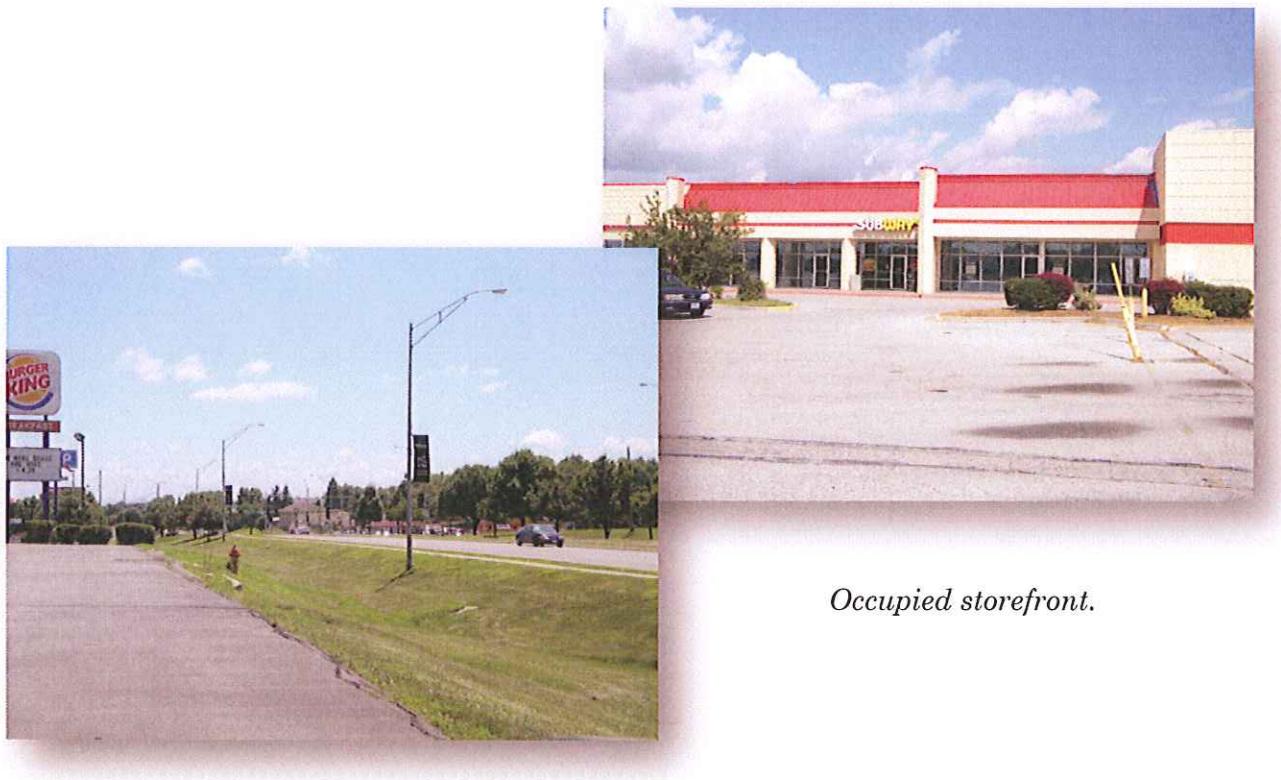
Occupied storefront.

No pedestrian sidewalks between businesses and 84th Street public sidewalk.

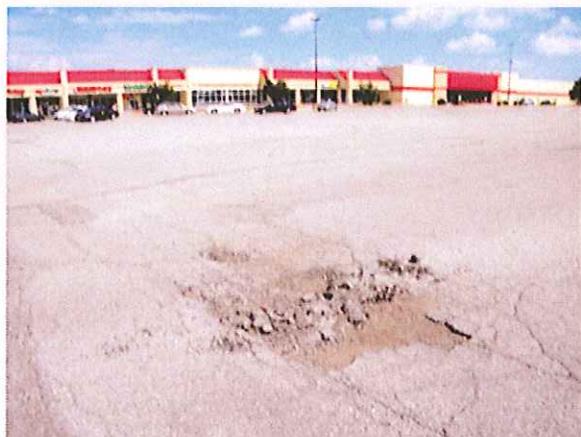
Brentwood Plaza

3. Parking lots throughout the **Redevelopment Area** lack designated pedestrian paths or sidewalks. If the parking lots would be fully occupied, pedestrians would need to walk up to a distance of approximately 300 to 400 feet from the rear of the lot to the front door of many retail establishments, through a deteriorated asphalt surfaced parking lot.

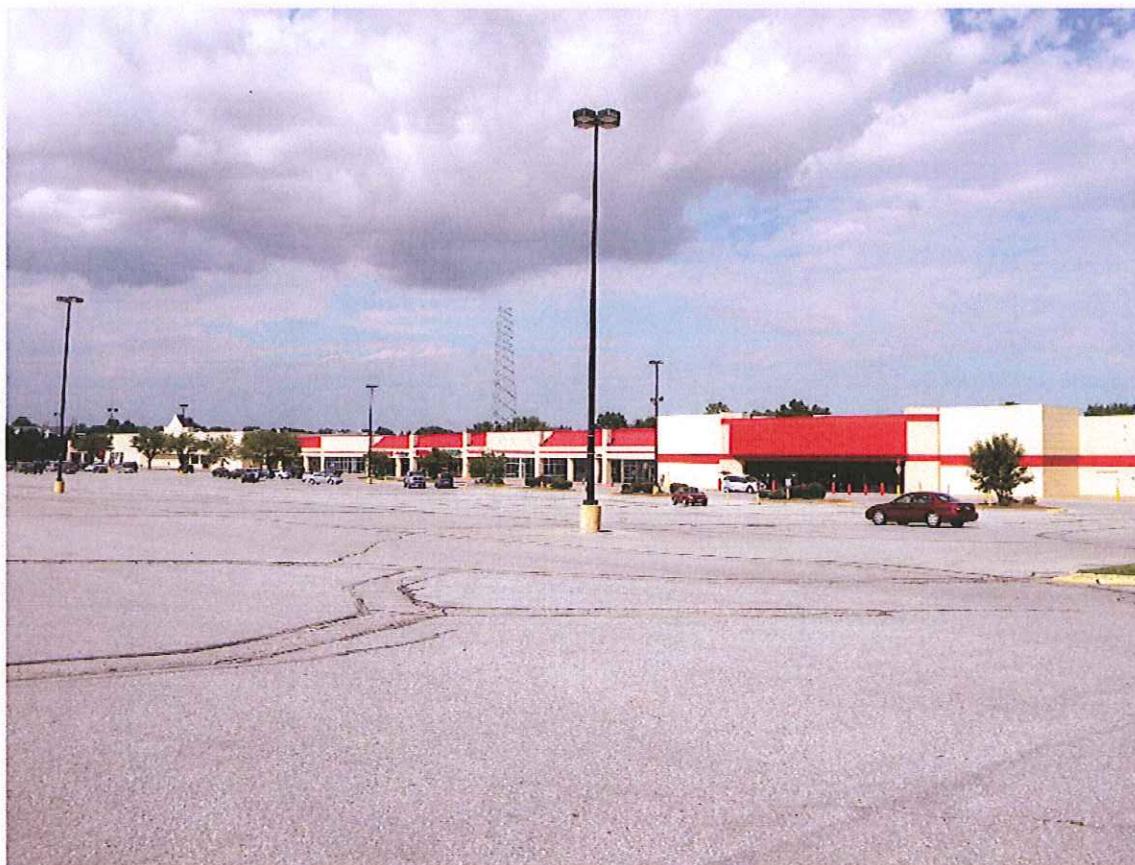
Former Walmart shopping center.

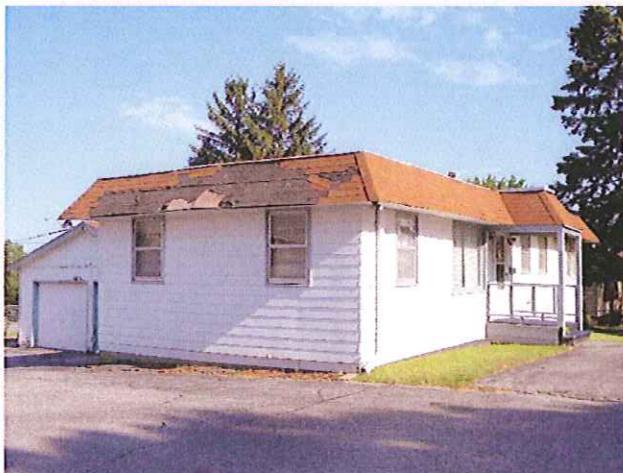
Located at 7405 S. 85th St.

The conditions which endanger life or property by fire and other causes are a strong presence throughout the 84th Street Redevelopment Area.

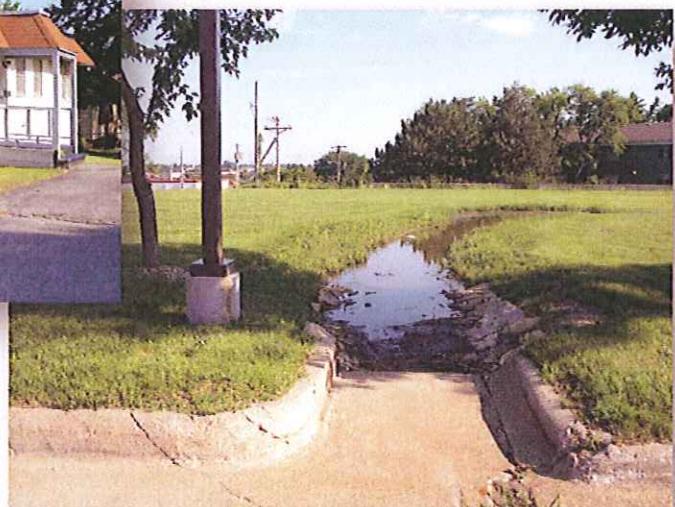
Located along the south side of the telephone building parking lot.

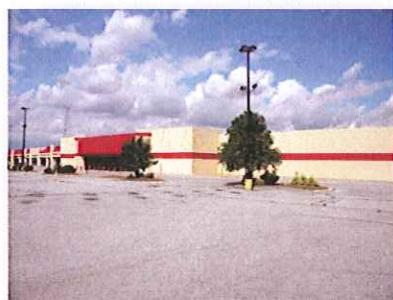
Former Walmart

Other Environmental, Blighted Factors are a strong presence throughout the 84th Street Redevelopment Area, containing a significant amount of functionally and economically obsolete commercial properties and a variety of undevelopable narrow width lots.

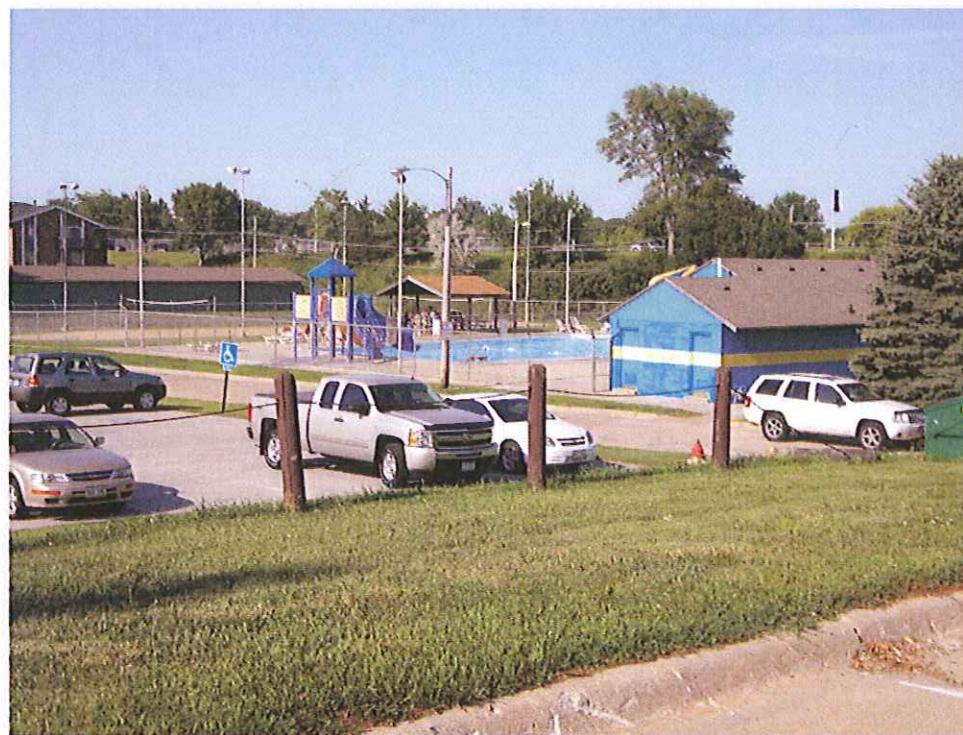
The Municipal Pool and Kelly McMahon Park are located approximately 20 feet below the elevation of the 84th Street public sidewalk and the adjacent Shadow Ridge Apartments.
