Blight/Substandard Determination Study "84TH Street Redevelopment Area"

La Vista, Nebraska

NOVEMBER 2011

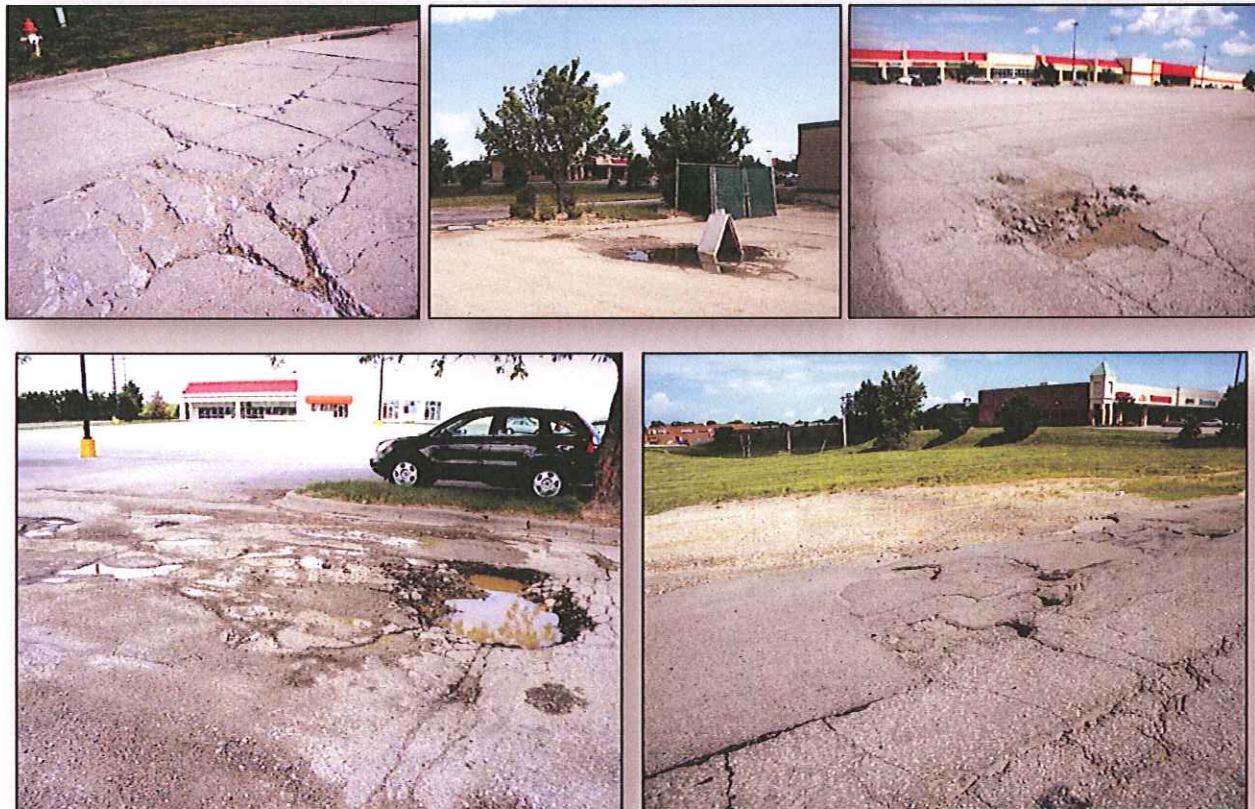
Defective or Inadequate Street Layout is a strong presence in the 84th Street Redevelopment Area due to a significant percentage of privately owned and maintained “frontage” streets that are significantly deteriorated. Large areas are impacted by “alligator cracking” and settling, as well as several potholes within street rights-of-way and in private parking lots. Many of these potholes are large enough to damage motor vehicles. Additional frontage street sections lack concrete curbs, gutters and storm water drainage systems.

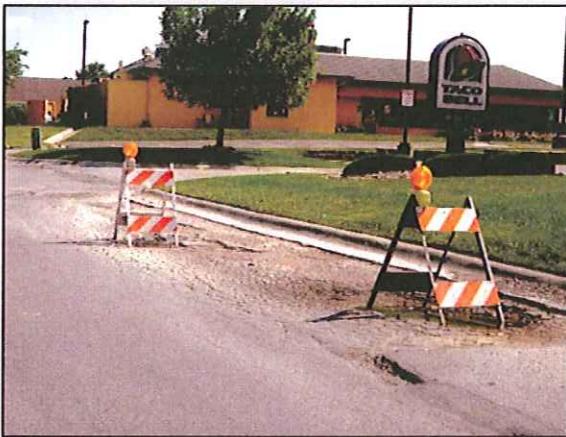
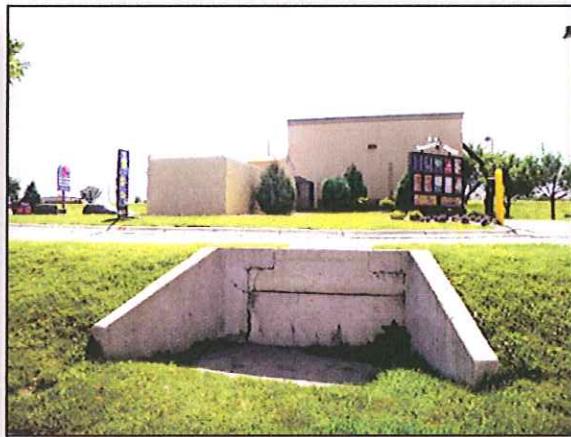
Insanitary or Unsafe Conditions are a strong presence throughout the entire the 84th Street Redevelopment Area. Conditions contributing to this Factor include poorly designed and implemented, privately owned, storm water surface drainage systems and the advanced age of privately owned and maintained underground water, sewer and storm sewer mains in the Redevelopment Area.

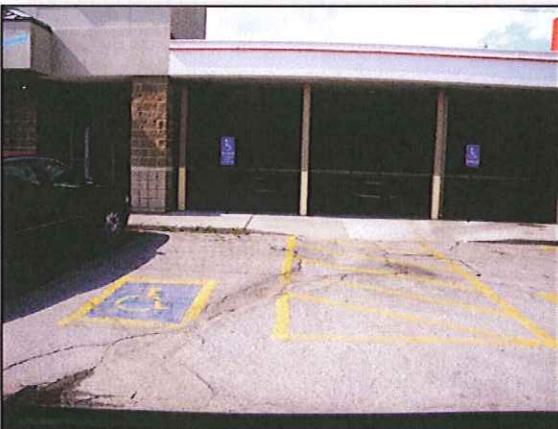
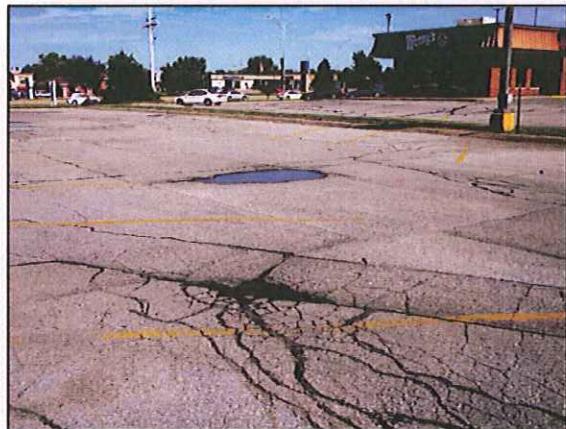
Deterioration of Site or Other Improvements is a strong presence throughout the Area, where, of the total 63 parcels examined, 44.4 percent, or 28 parcels have "fair" to "poor" overall site conditions.

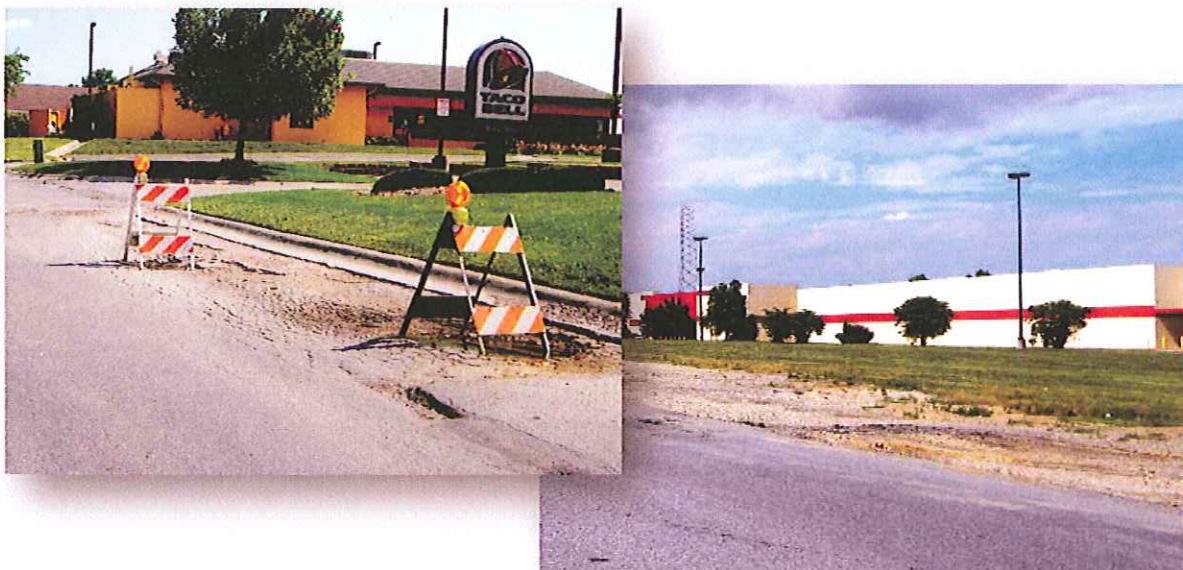
The existence of defective or inadequate street layout in the **84th Street Redevelopment Area** is a strong presence and constitutes a **Blight Factor**.

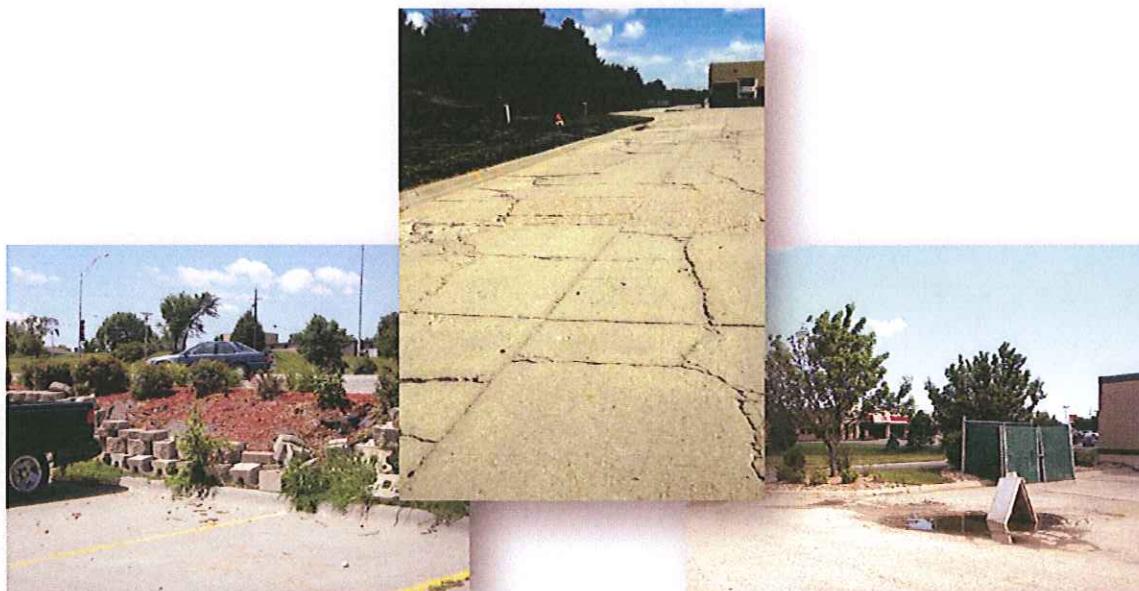
1. Many buildings and/or shopping facilities throughout the **Area** are accessed by asphalt or concrete surfaced streets. Several segments of privately owned "frontage streets" were observed to lack concrete curbs and gutters and thus have open storm water drainage ditches. These frontage roads were also observed to be severely deteriorated with large areas impacted by cracking and settling. Many of these street segments also have several potholes, some that are large enough to damage vehicles to the extent that they are barricaded to divert traffic. As a result, these roads can become impassable during inclement weather. Ponding water in the areas with settling, potholes and storm water drainage ditches can attract mosquitoes and other pests.
