**CITY OF LA VISTA  
MAYOR AND CITY COUNCIL REPORT  
AUGUST 17, 2021 AGENDA**

| <b>Subject:</b> | <b>Type:</b> | <b>Submitted By:</b> |
|---|---|---|
| ROTELLA'S ITALIAN BAKERY BLIGHT &<br>SUBSTANDARD DECLARATION | ◆ RESOLUTION<br>ORDINANCE<br>RECEIVE/FILE | BRUCE FOUNTAIN<br>COMMUNITY DEVELOPMENT<br>DIRECTOR |

Blight & Substandard Determination Study.

## ROTELLA'S ITALIAN BAKERY REDEVELOPMENT AREA LA VISTA, NEBRASKA

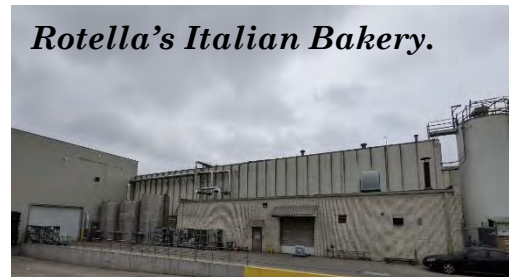
*Rotella's Italian Bakery.*

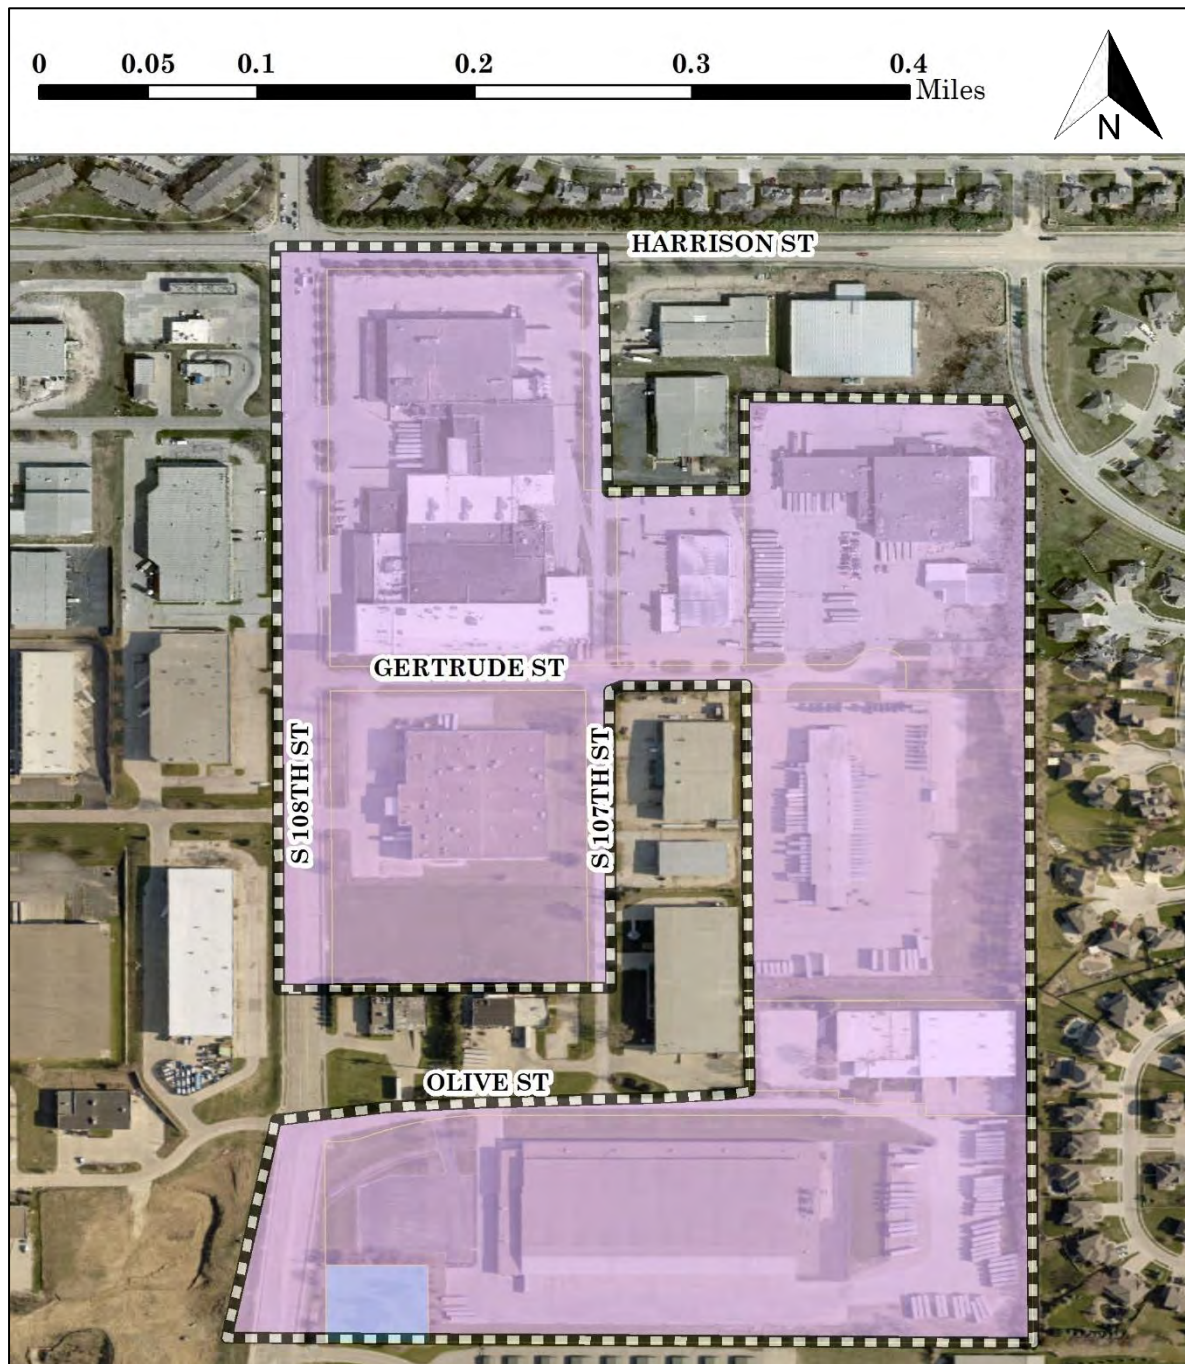
# EXISTING LAND USE MAP – ILLUSTRATION 2

**Table 3** identifies the estimated **Existing Land Use** within **Redevelopment Area**, in terms of number of acres and percentage of total for all existing uses. A map of **Existing Land Use** is also presented in **Illustration 2, Page 14**.

Industrial land uses comprise approximately 55.9 acres or 83.4 percent of the total land use in the **Redevelopment Area**. Millard Manufacturing is an industrial building with on-site offices. The Rotella’s Italian Bakery Facility includes a combined office, industrial bakery and retail store within one connected structure. Portal Cemetery includes less than an acre of land and comprises approximately 1.2 percent of the total land area. Streets and public right-of-ways comprise approximately 10.3 acres or 15.4 percent of the **Redevelopment Area**.

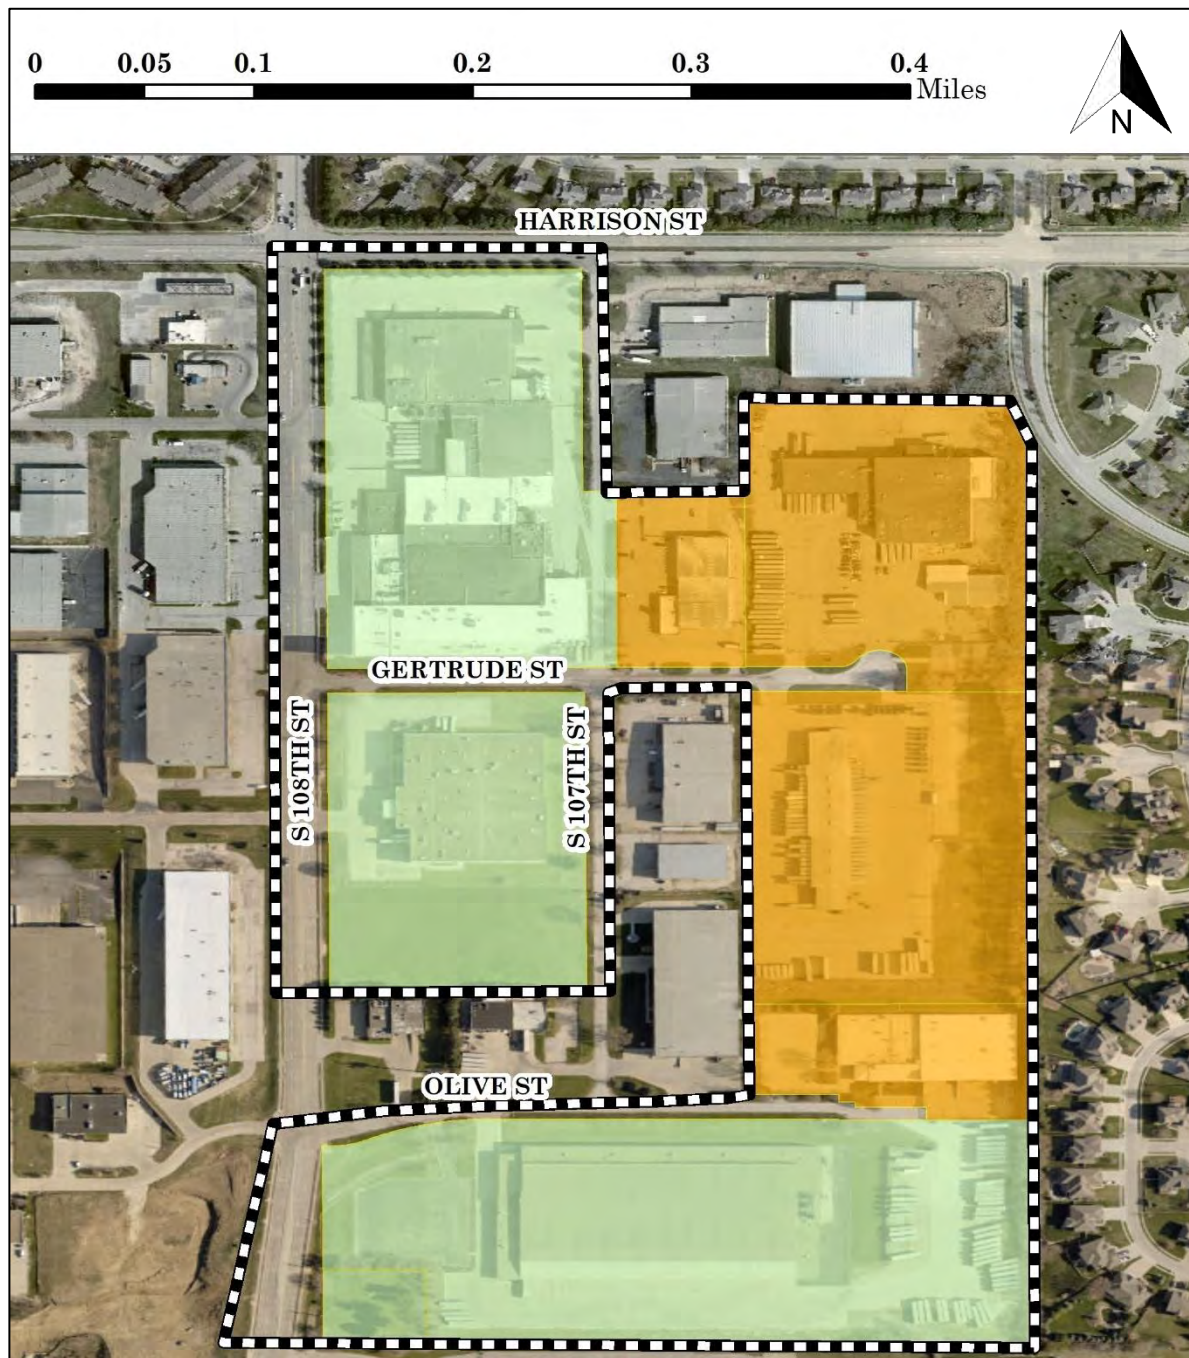
Street conditions within the **Redevelopment Area** were, generally, found to be in “good” or “fair” condition. This includes five public streets. Of the eight total parcels, four (50 percent) were found to front streets in “fair” condition. Seven of the parcels had parking surfaces rated deteriorated to a minor extent, or worse. The installation of modern infrastructure and utility systems may be required to attract new development and support redevelopment opportunities throughout the **Redevelopment Area**.

**Illustration 7, Page 32,** identifies **Street Conditions** in the **Redevelopment Area**.

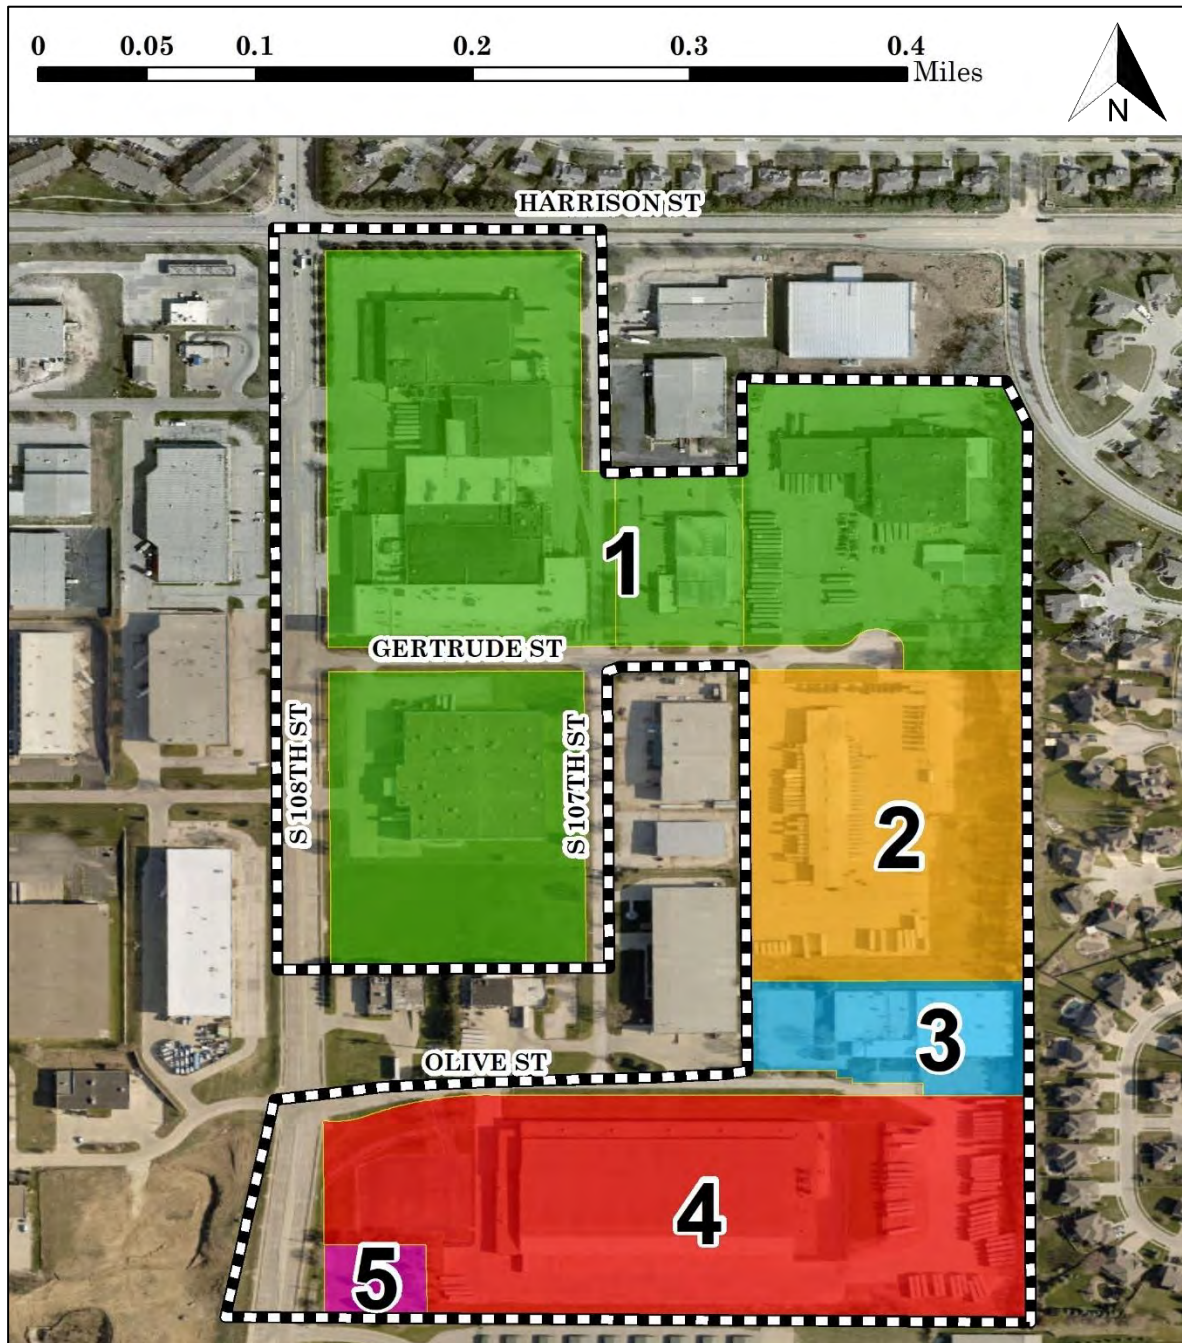
A total of **five individuals** or **ownership groups** own property within the **Rotella's Italian Bakery Redevelopment Area**. Approximately half of the **Redevelopment Area** is owned by Rotella's Italian Bakery. The Portal Cemetery, a public/quasi-public use, and associated public streets and right-of-ways, are also located throughout the **Area**. Land assemblage of larger proportions is necessary for major developments to be economically feasible and attract financial support. Public patronage is also required to repay such financial support. Such assemblage is difficult without public intervention. **Illustration 9, Page 38**, identifies the **Diversity of Ownership** in the **Redevelopment Area**.

#### FIVE DISTINCT OWNERS/OWNERSHIP GROUPS
